Randolph Elementary School

Multimodal Access Opportunity Scores

Summary Conditions

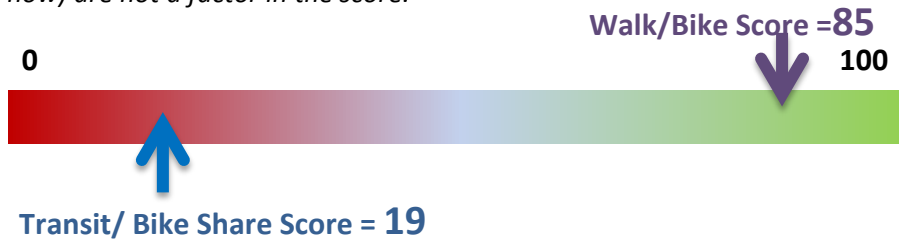
This score is based on the physical assets and barriers that determine each school or site's potential for increased walking, bicycling, carpooling and bus/transit use. Current travel modes (how people are accessing the school now) are not a factor in the score.
