Notice of Addendum No.2

Invitation to Bid Title: Arlington Science Focus Elementary School - Kitchen Renovation Project

The results of GALE's roof condition survey of the school using RoofPro's Roof Condition Index (RCI) are as follows:

ARLINGTON PUBLIC SCHOOLS ROOF CONDITION SURVEY

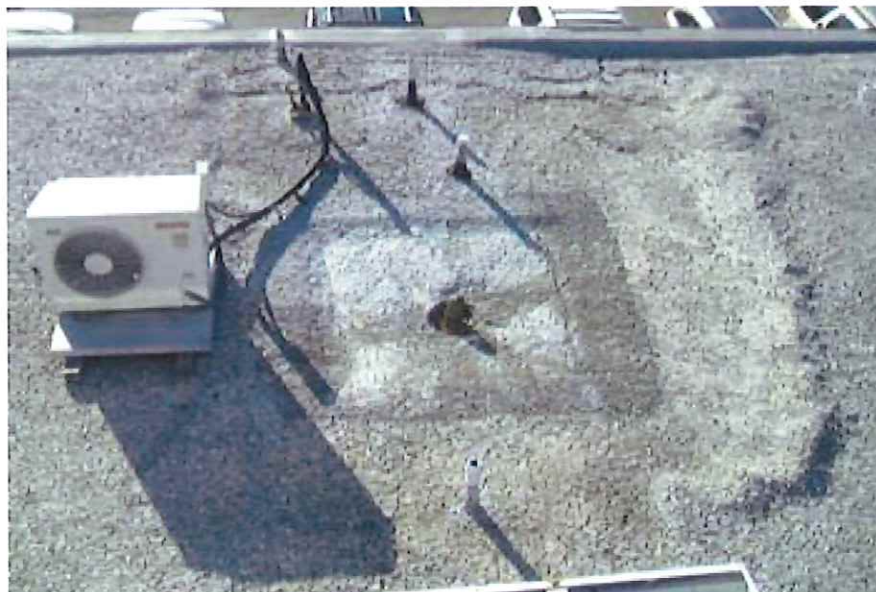
Photo 2: Extensive roof drain repair work on Area F

School Name:	Arlington Science Focus Elementary School		Roof Section	F
Address	1501 N. Lincoln St., 22201			
System Type	Built-Up Asphalt Roofing	Approx. Square Feet	4,300	
Personnel	RTB	Survey Dates	1/7/10	
Surfacing	Gravel	Approx. Roof Age	9 years	
Membrane	BUR-4Ply			
Perimeter	Parapet wall / roof edge			
Flashing Membrane/Metal	Mod-Bit 2-ply / 24 gauge prepainted steel			
Rising Wall Type	Brick masonry wall / windows			
Building Construction Type	Steel frame with brick masonry walls			
Roof Slope/Drainage	±1/4-inch per foot / internal drains			
Roof Leak/Repair History	No leaks reported / large areas repairs noted			
General Conditions				Rating
Membrane	<ul style="list-style-type: none"> Fair – extensive gravel displacement, large areas of repair, ponding 			56 – 70
Flashings	<ul style="list-style-type: none"> Fair – edge strippings repaired, base flashings moderately deteriorated, large repairs at drain sumps 			41 -55

Sheet Metal	<ul style="list-style-type: none"> Good 			56- 70
Drainage	<ul style="list-style-type: none"> Fair – poor slope to drains, moderate ponding 			56 – 70
Rising Walls	<ul style="list-style-type: none"> N/A 			N/A
Remaining Service Life	8 – 12 years			
Recommendations	Perform repairs to extend service life			
Repairs	Repair drain sumps and membrane defects			
Approx. Repair Cost	\$3,500 - \$5,000			
Approx. Replacement Cost	N/A

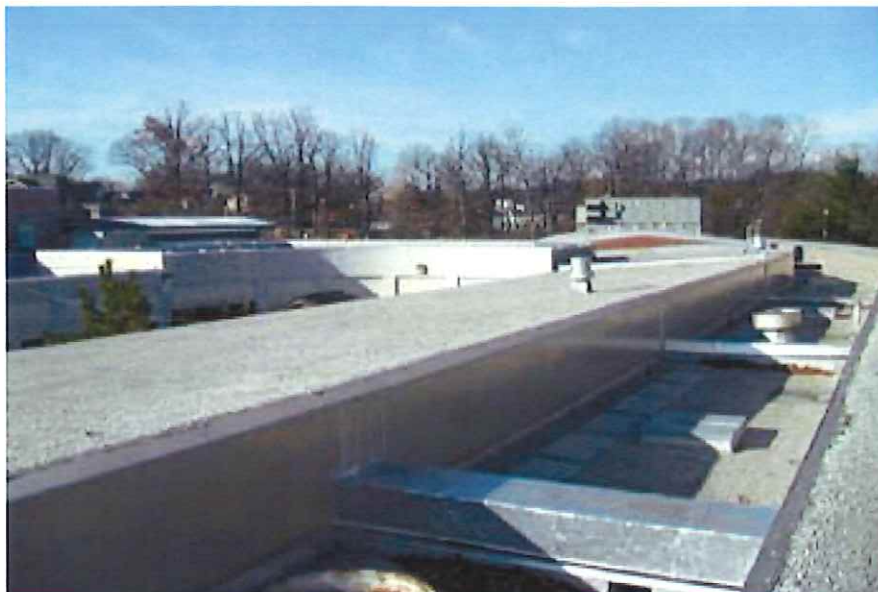
Photo 3: Moderate debris/vegetation on Area B

School Name:	Arlington Science Focus Elementary School		Roof Section	B
Address	1501 N. Lincoln St., 22201			
System Type	Built-Up Asphalt Roofing	Approx. Square Feet	4,500	
Personnel	RTB	Survey Dates	1/7/10	
Surfacing	Gravel	Approx. Roof Age	9 years	
Membrane	BUR-4Ply			
Perimeter	Rising walls			
Flashing Membrane/Metal	Mod-Bit 2-ply / 24 gauge prepainted steel			
Rising Wall Type	Flush seam metal panels / brick masonry			
Building Construction Type	Steel frame with brick masonry walls			
Roof Slope/Drainage	±1/4-inch per foot / internal drains			
Roof Leak/Repair History	No leaks reported / drain sump repairs noted			
General Conditions				Rating
Membrane	<ul style="list-style-type: none"> Good – minor alligatoring, exposed felts 			56 – 70
Flashings	<ul style="list-style-type: none"> Fair – edge strippings repaired, base flashings moderately deteriorated 			41 -55

Sheet Metal	<ul style="list-style-type: none"> Good 			56- 70
Drainage	<ul style="list-style-type: none"> Good – debris, vegetation at roof drains 			56 – 70
Rising Walls	<ul style="list-style-type: none"> Good 			71 – 85
Remaining Service Life	8 – 12 years			
Recommendations	Perform yearly maintenance			
Repairs	N/A			
Approx. Repair Cost	N/A			
Approx. Replacement Cost	N/A

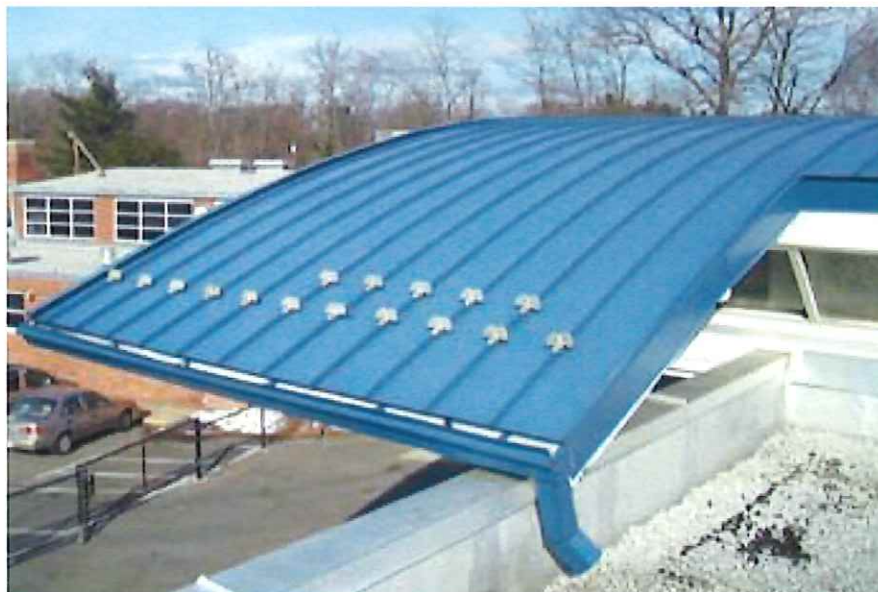
Photo 4: Barrel roof standing seam minor missing snowguards on Area N.

School Name:	Arlington Science Focus Elementary School		Roof Section	N
Address	1501 N. Lincoln St., 22201			
System Type	Standing Seam Sheet Metal Roofing	Approx. Square Feet	1,100 sf	
Personnel	RTB	Survey Dates	1/7/10	
Surfacing	Kynar	Approx. Roof Age	9 years	
Membrane	Metal			
Perimeter	Roof edge			
Flashing Membrane/Metal	Metal / 24 gauge prepainted steel			
Rising Wall Type	N/A			
Building Construction Type	Steel frame with brick masonry walls			
Roof Slope/Drainage	Barrel roof slope varies / gutter and downspouts			
Roof Leak/Repair History	No leaks reported / no repairs noted			
General Conditions				Rating
Membrane	<ul style="list-style-type: none"> Very good – minor chalking, deterioration of metal panels 			71 – 85
Flashings	<ul style="list-style-type: none"> Very good 			71 – 85

Sheet Metal	<ul style="list-style-type: none"> Very good 			71 – 85
Drainage	<ul style="list-style-type: none"> Good – isolated missing snow guards 			56 – 70
Rising Walls	<ul style="list-style-type: none"> N/A 			N/A
Remaining Service Life	20 – 30 years			
Recommendations	Perform repairs to extend service life.			
Repairs	Replace missing snow guards.			
Approx. Repair Cost	\$1,000 - \$2,000			
Approx. Replacement Cost	N/A
