**Arlington
Public
Schools**

**Long-Range Plan to Renovate Existing School Facilities:
Project Report**

MTFA
architecture

October 26, 2023

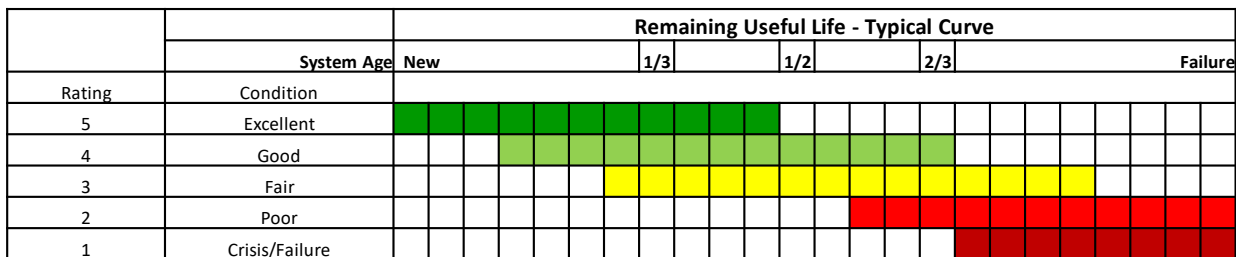
Fig. 3 – Rating System Definitions

The following tables provide the basis of the rating system that is described in this reference guide. Refer to the individual systems for definitions of deficiencies and other items to consider in completing the evaluations.

Rating	Condition	% Deficiencies Allowed
5	Excellent	0-5%
4	Good	5-10%
3	Fair	10-25%
2	Poor	25-50%
1	Crisis/Failure	>50%

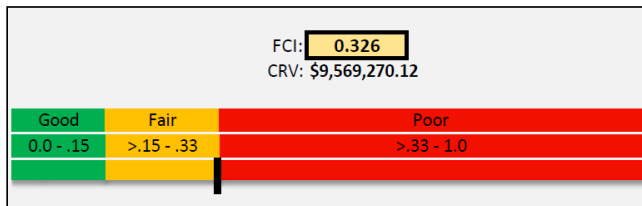
The FCI provides a relative measure of the condition of a building within a group or portfolio of buildings. For this evaluation, the range of FCI is depicted as Good/Fair/Poor. The FCI is the number depicted on the sliding scale and represents the composite calculation of each of the system-level indicators described below.

The FCI range can be used, along with other factors such as building system condition and other building characteristics, to determine the appropriate maintenance, repair, and replacement actions, or in this case, can be used by the Master Planning team to refer to

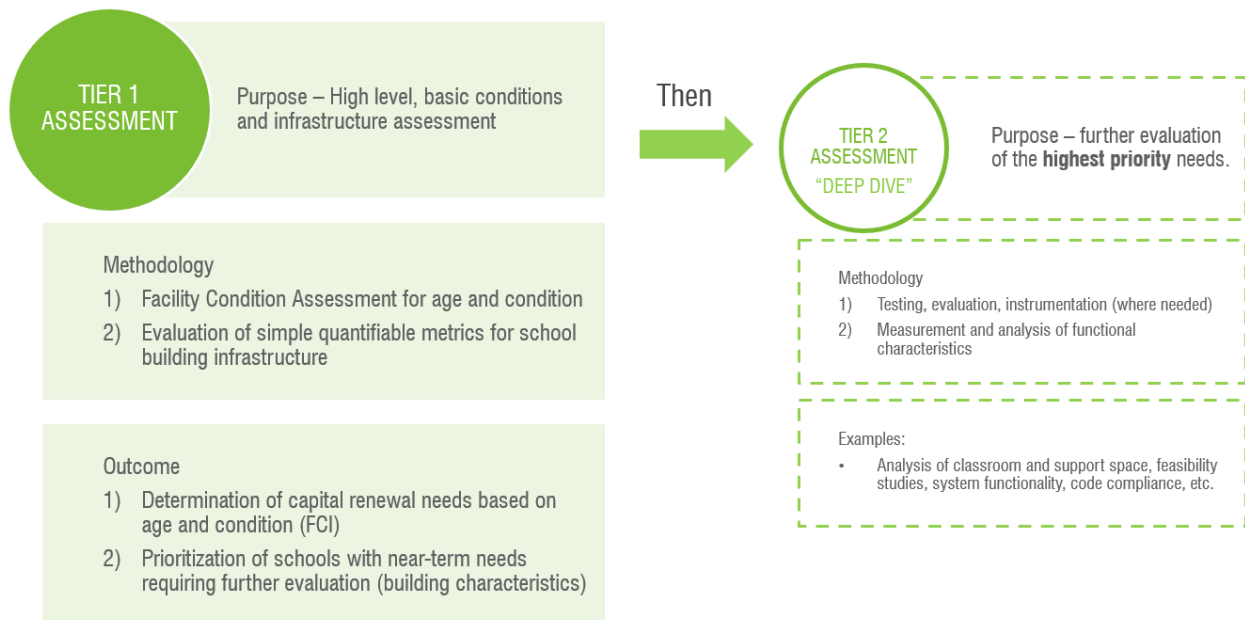
Fig. 4 – Tiered Level of Assessment Diagram

The MTFA team presented a proposed tiered level of assessment approach that differentiates high level, basic conditions analysis from more in-depth evaluation (see Fig. 4):

- A Tier 1 assessment determines system age and condition and evaluates simple quantifiable metrics. This level of assessment is consistent with the expectations for analysis in this project.
- A Tier 2 assessment (also referred to as a “deep dive”) involves additional measurement, testing, analysis, or study to further evaluate the highest priority needs and deficiencies identified in the Tier 1 assessment. This level of assessment would be a future additional effort not part of this project.
